PHOTOGRAPHS

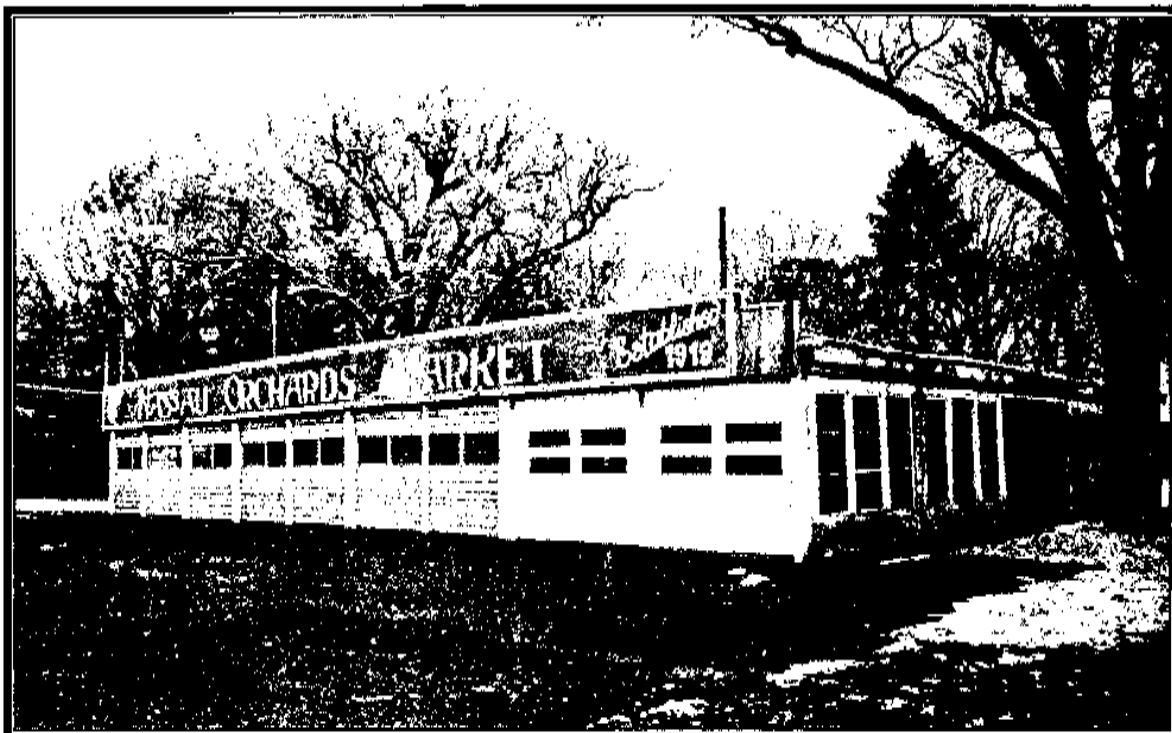
Photograph 1. S-11519, Nassau Orchards Market, Roadside Produce Stand, front (south) and east sides, facing northwest.

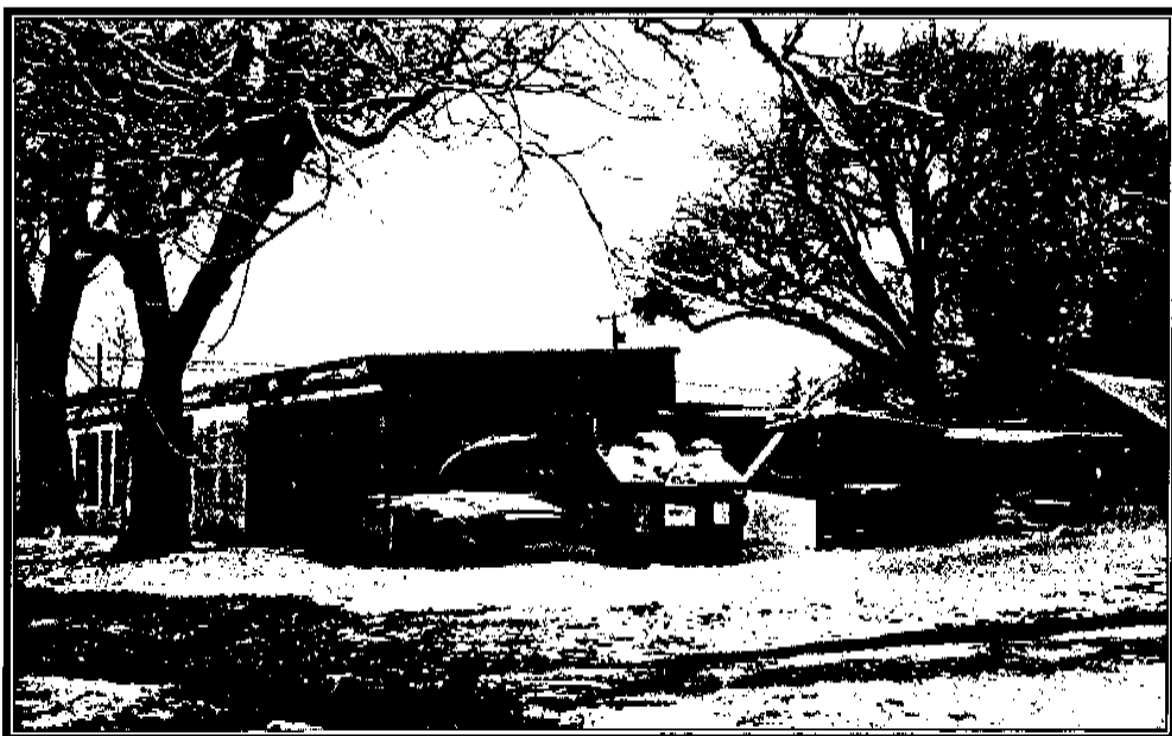
Photograph 2. S-11519, Nassau Orchards Market, Roadside Produce Stand, rear (north) and east sides, facing west.

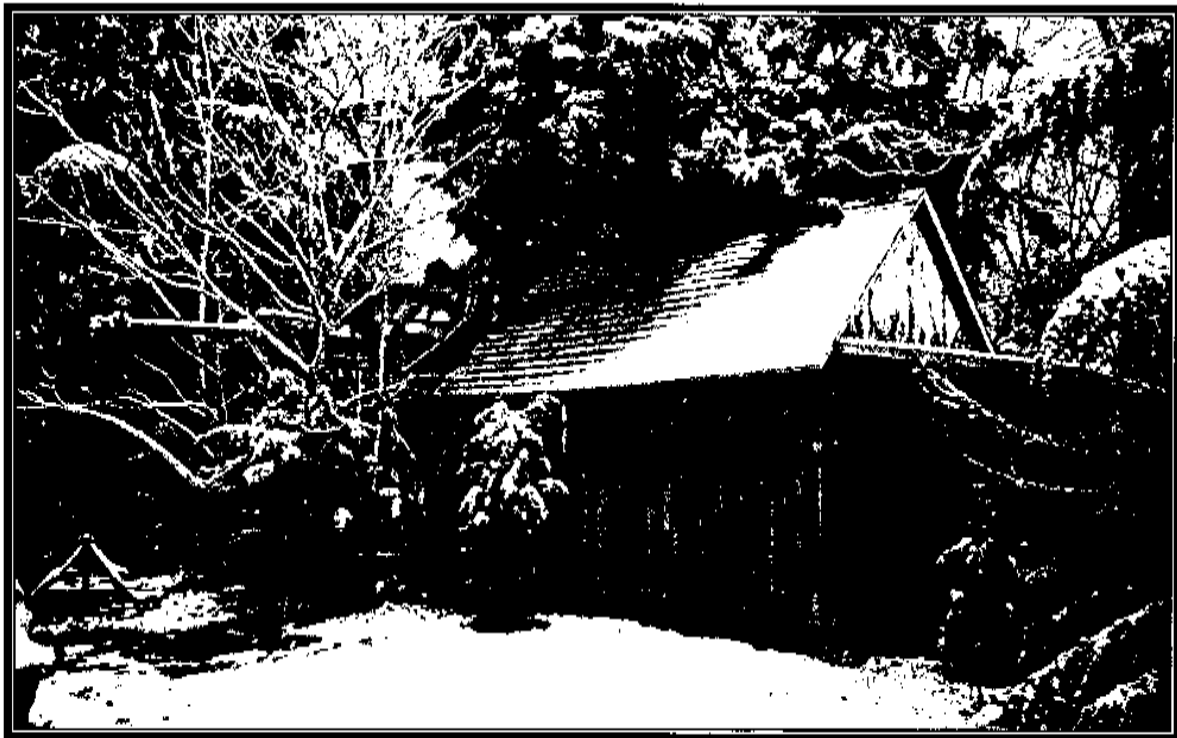
Photograph 3. S-11519, Nassau Orchards Market, pesticide storage shed and water tower, facing northeast.

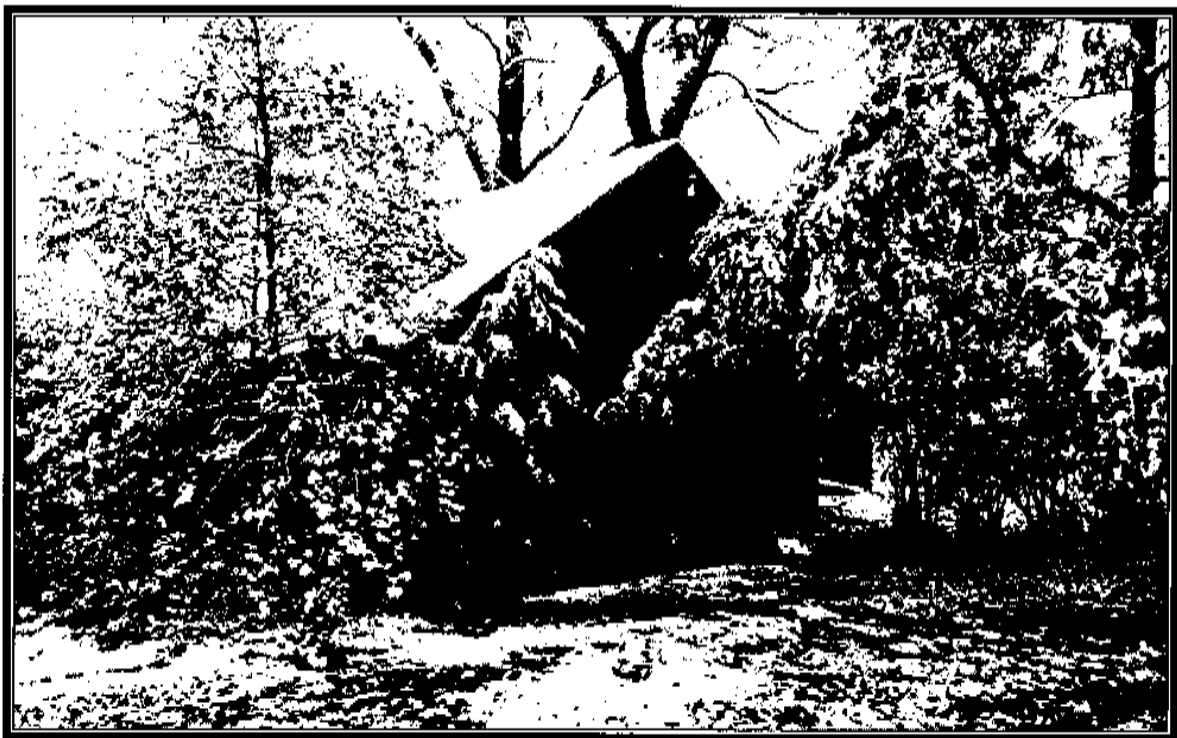
Photograph 4. S-11519, Nassau Orchards Market, garage, facing southeast.

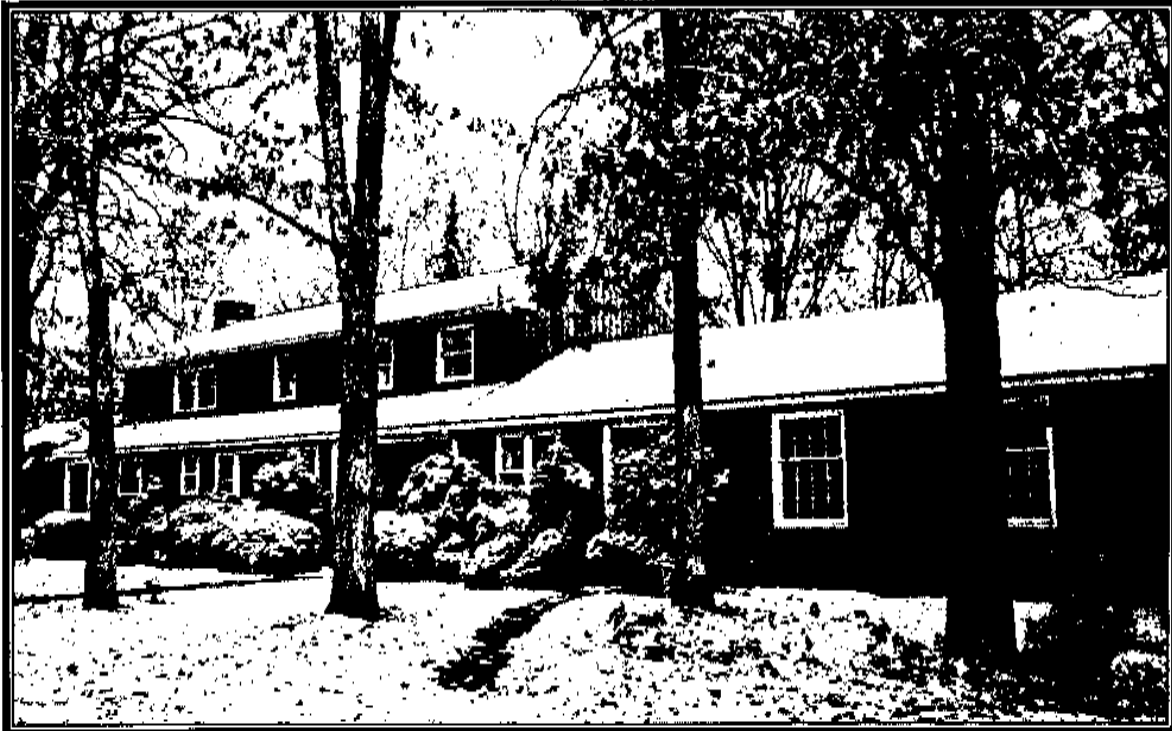
Photograph 5. S-11519, Nassau Orchards Market, house facade and garage addition, facing northwest.

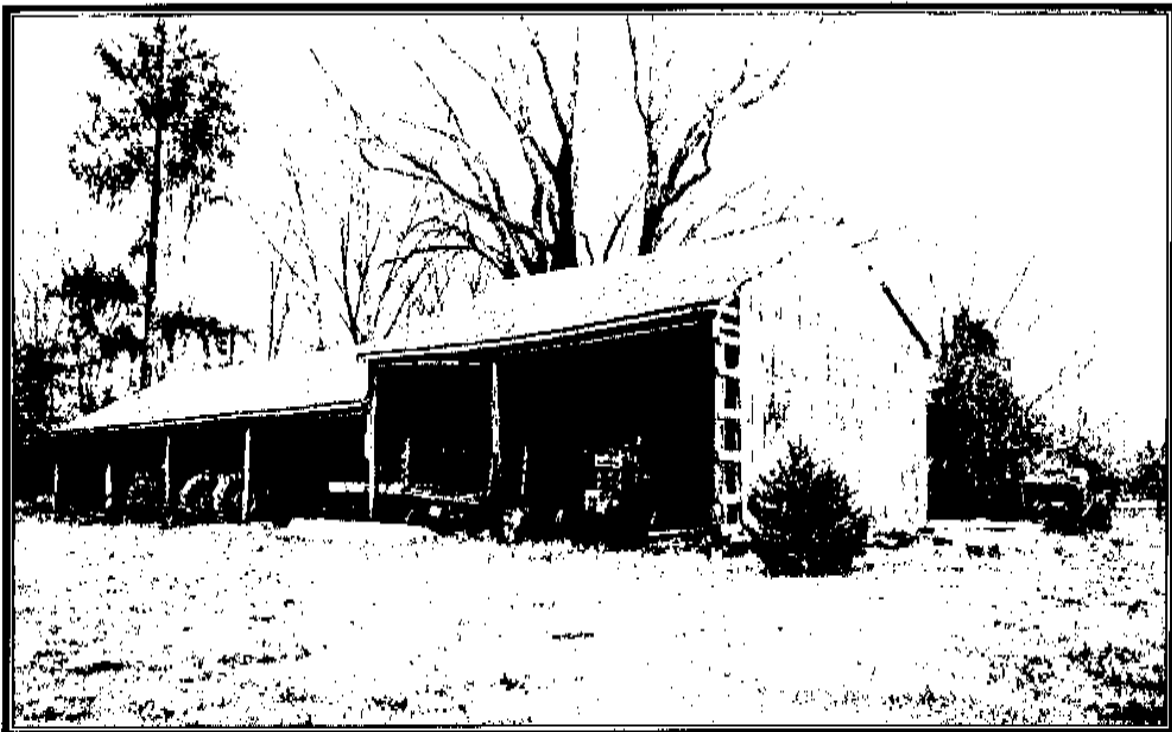
Photograph 6. S-11519, Nassau Orchards Market, equipment barn, facing northwest.

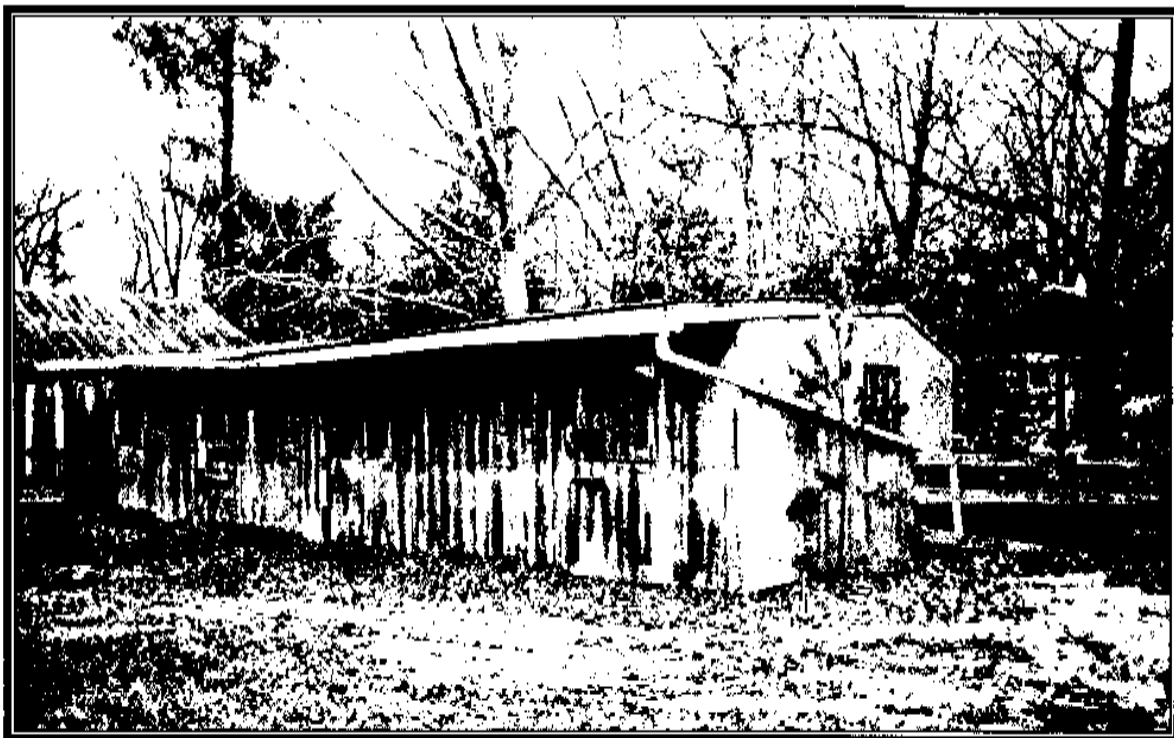
Photograph 7. S-11519, Nassau Orchards Market, stable, facing west.

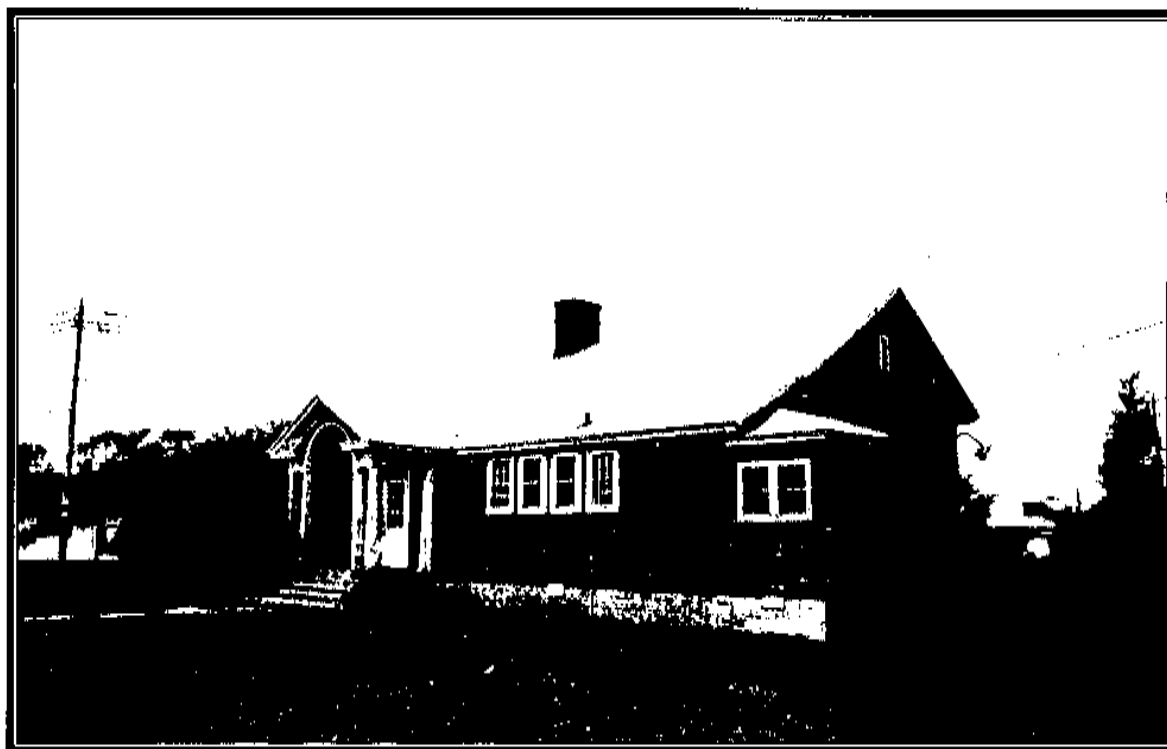
Photograph 8. S-8393, Belttown Historic District, the Nassau Colored School, facing northwest. The building is a contributing resource and also individually eligible for NRHP listing.

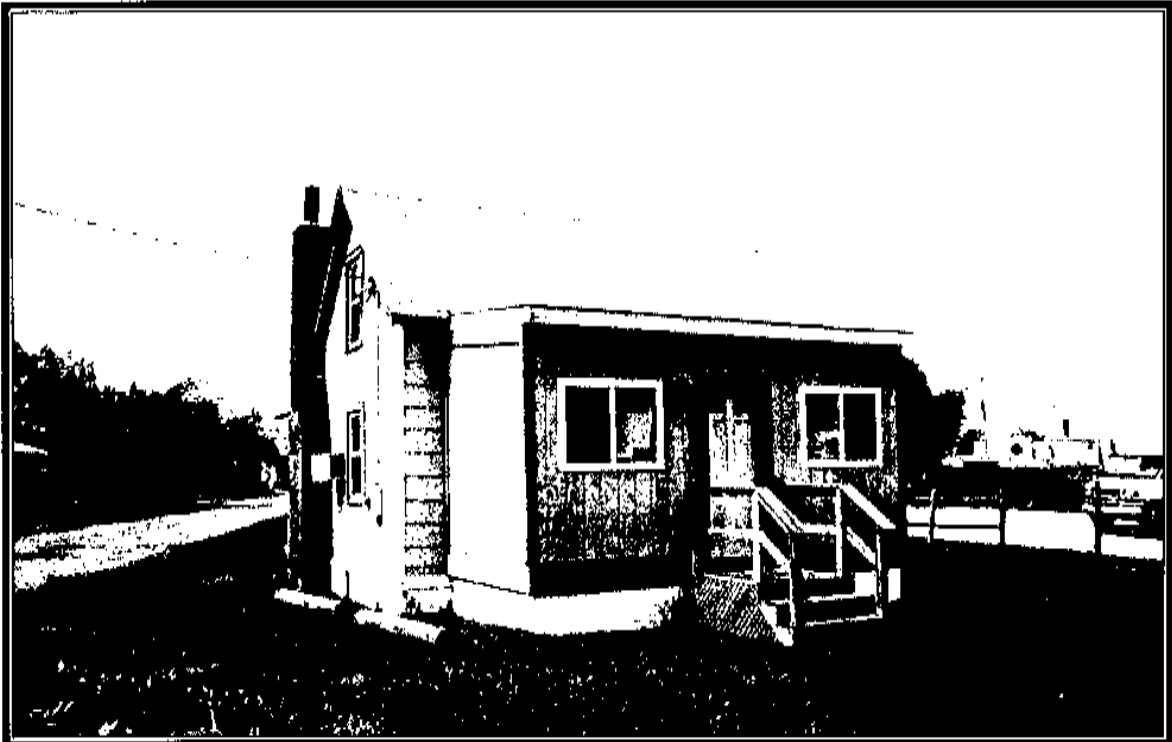
Photograph 9. S-8393, Belltown Historic District, house on lot 3-34-5-113, facing north. It corresponds to Plate 10 in the Tidlow et al. 1990 report. It is now evaluated as noncontributing due to alterations. Note the enclosed porch, replacement windows, and new siding.

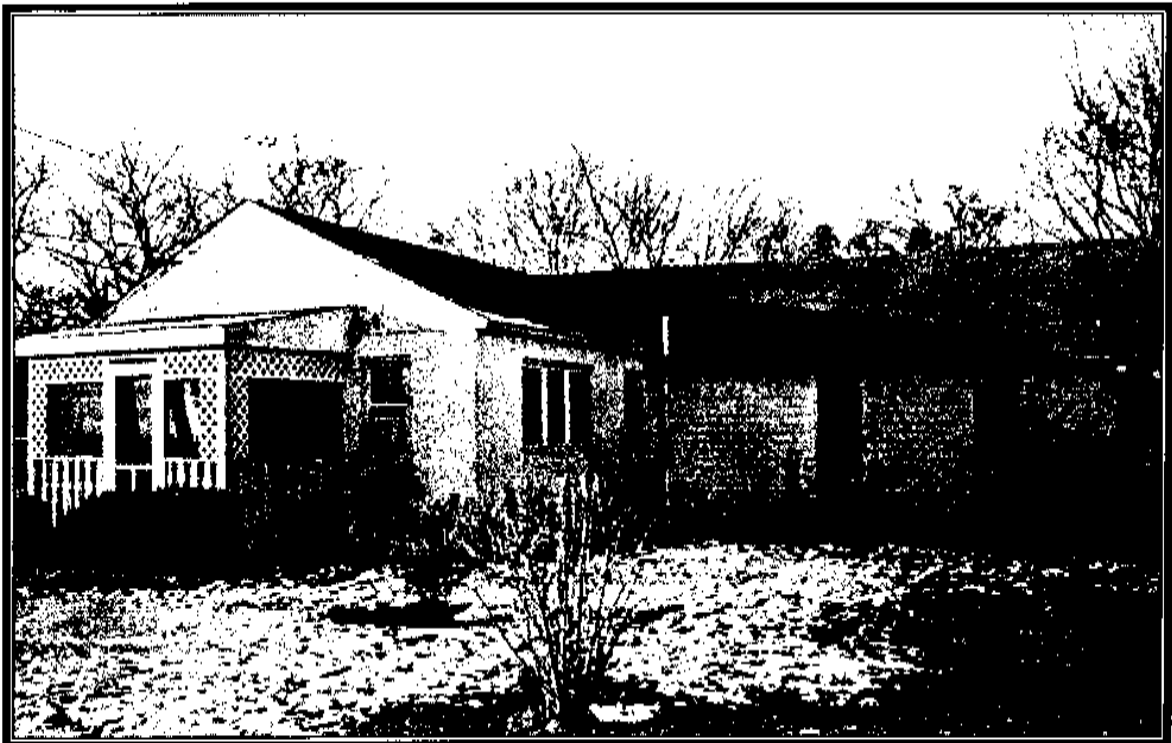
Photograph 10. S-8393, Belltown Historic District, house on lot 3-34-5-115, facing northwest. It was evaluated as noncontributing in the original evaluation.

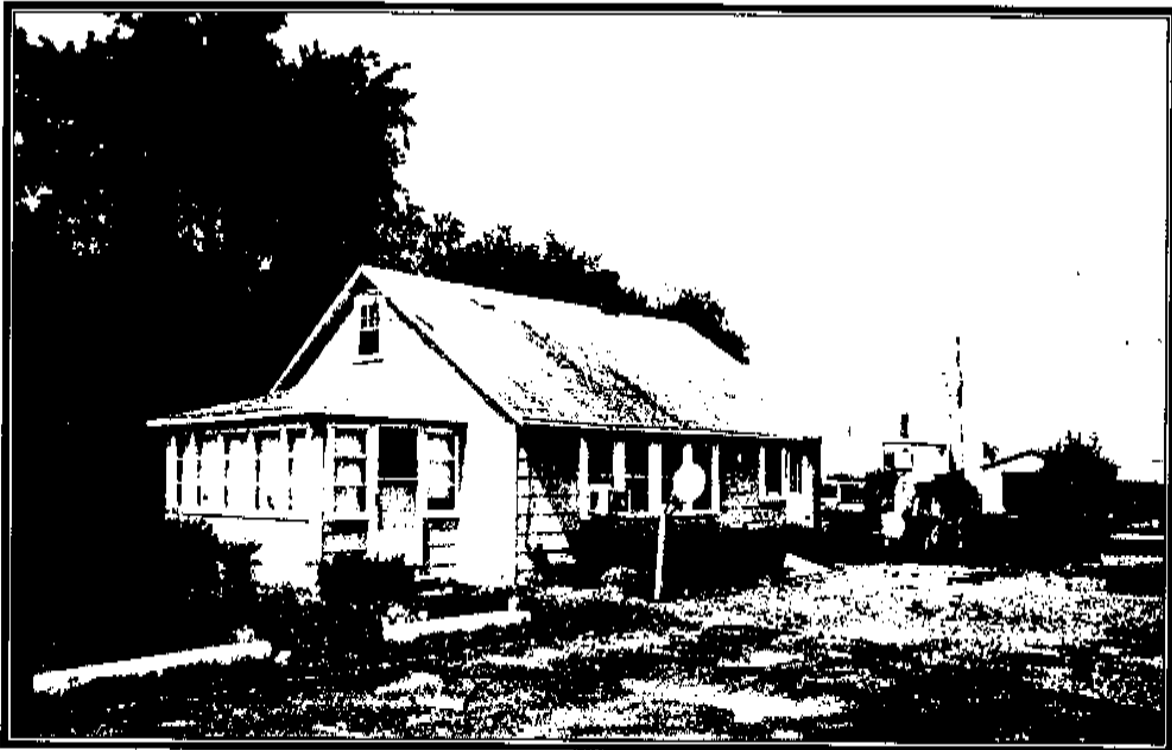
Photograph 11. S-8393, Belltown Historic District, house not included in the original Belltown Historic District boundary, facing northeast. It would be a contributing resource.

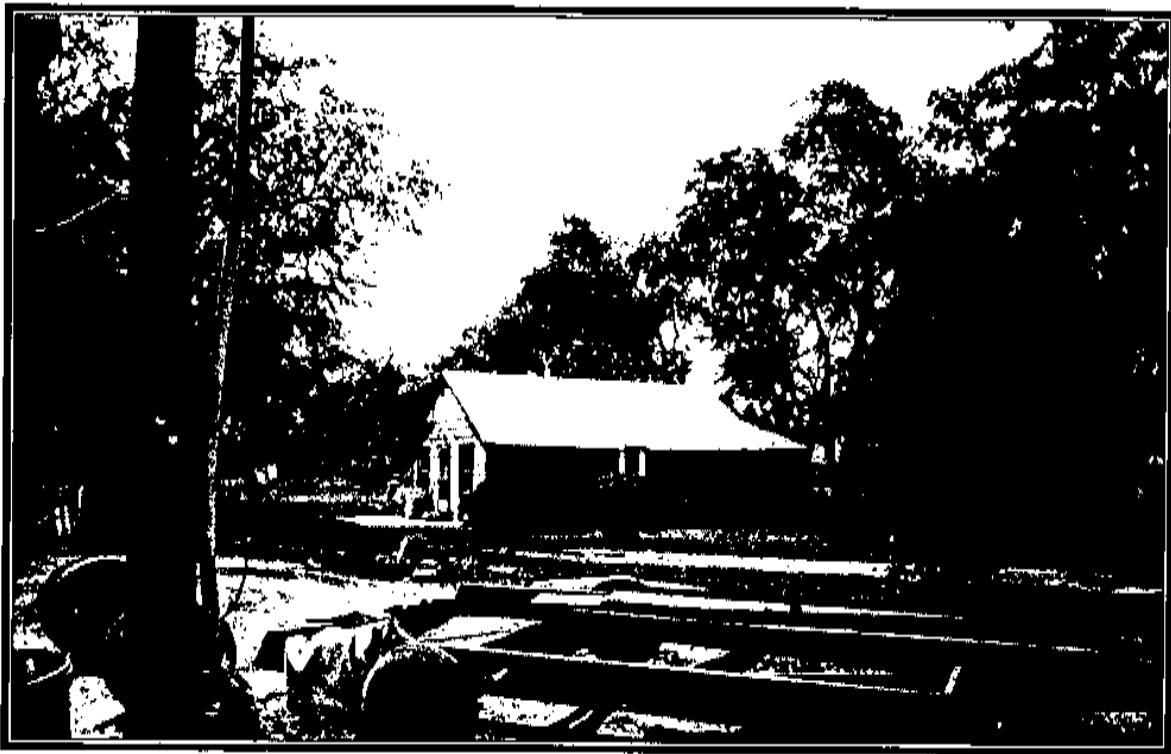
Photograph 12. S-8393, Belltown Historic District, house not included in the original Belltown Historic District boundary, facing northwest. It would be a contributing resource.

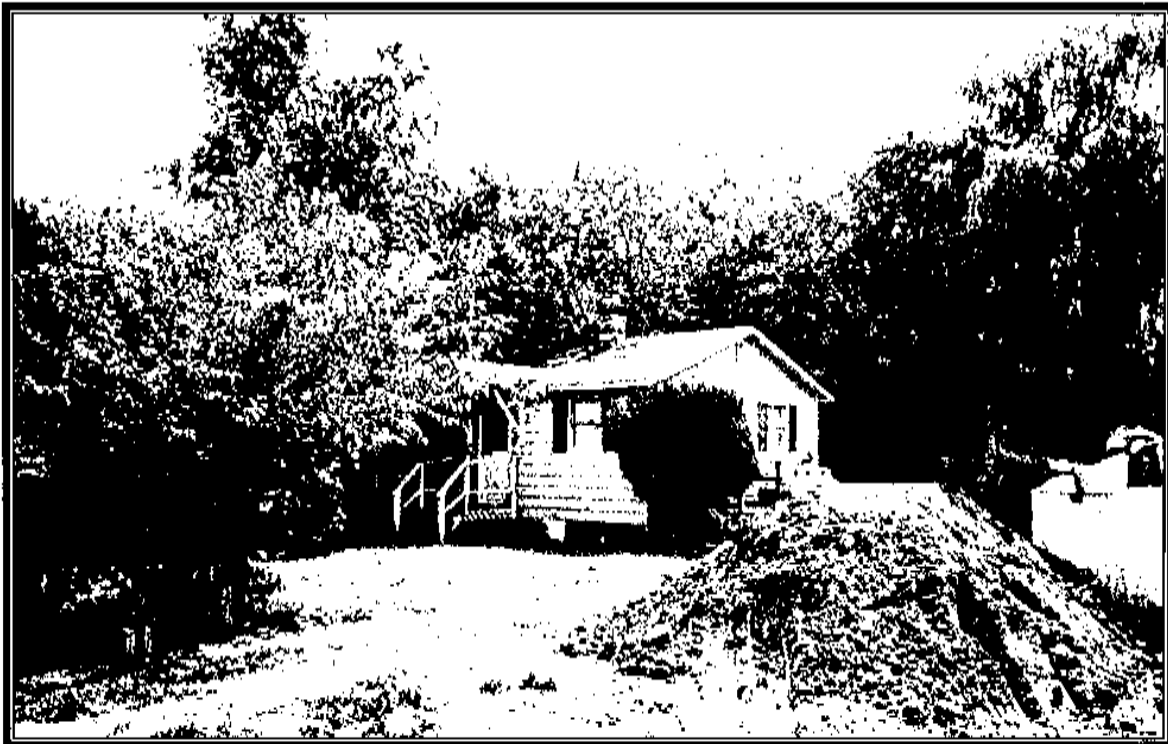
Photograph 13. S-8393, Belltown Historic District, house not included in the original Belltown Historic District boundary, facing west. It would be a contributing resource.

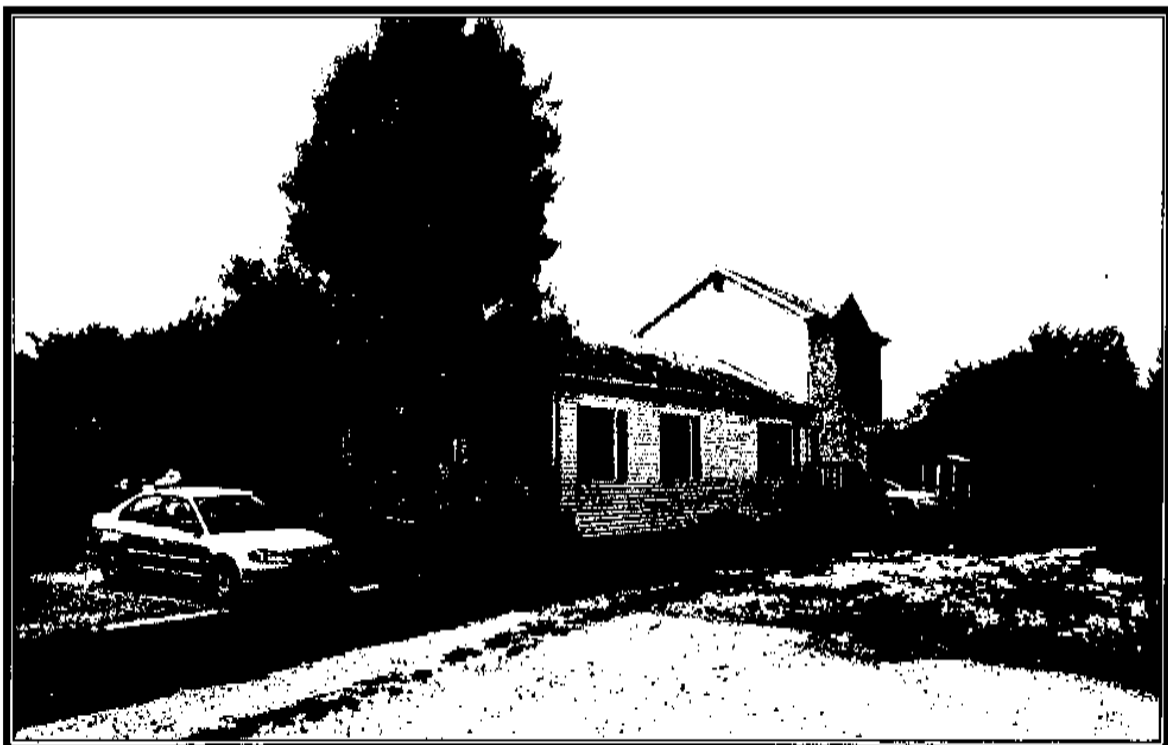
Photograph 14. S-8393, Belltown Historic District, house on lot 3-34-5-122, facing northwest. It replaced the contributing house shown as Plate 11 in the Tidlow et al. 1990 report.

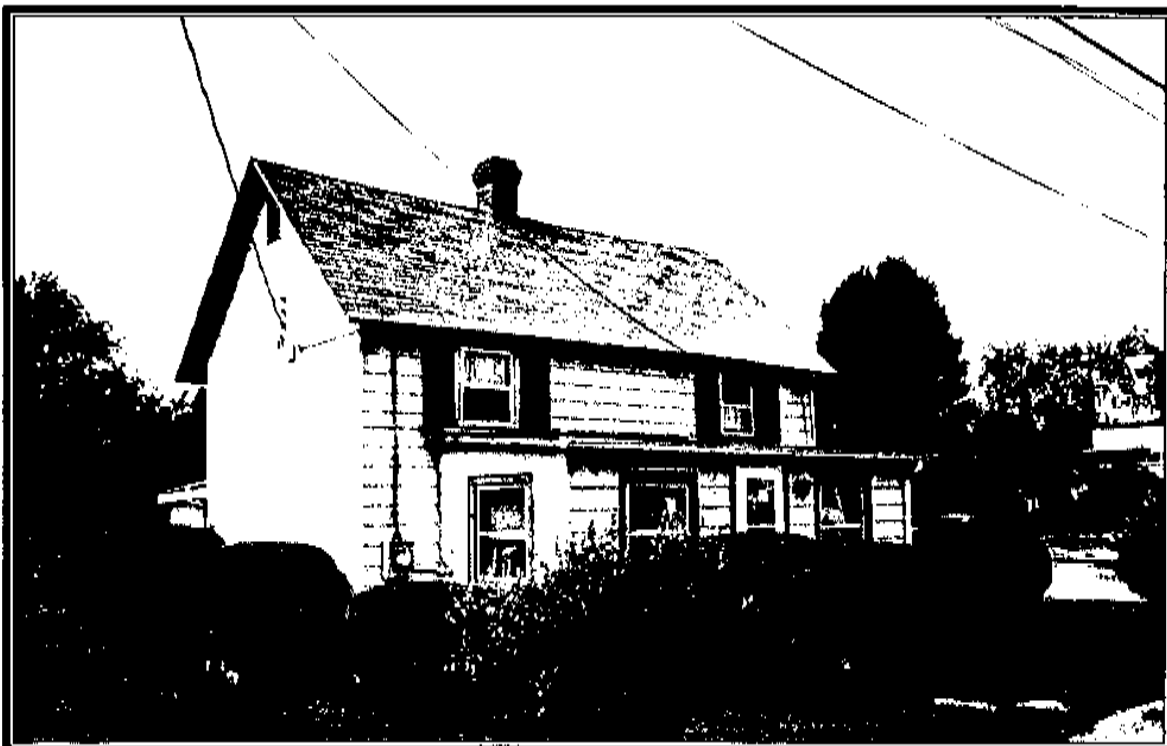
Photograph 15. S-8393, Belltown Historic District, house on lot 3-34-5-124, facing northeast. Evaluated as a contributing resource in 1989, it has not substantially changed. The house is shown as Plate 12 in the Tidlow et al. 1990 report.

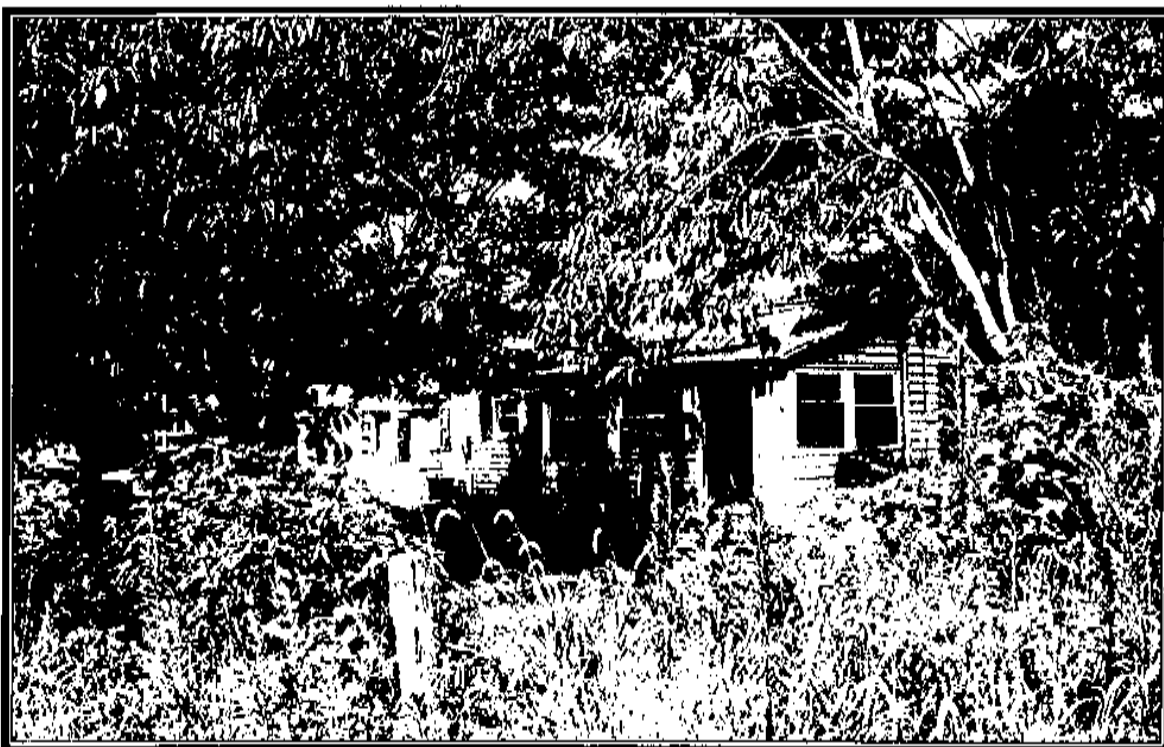
Photograph 16. S-8393, Belltown Historic District, house not included in the original Belltown Historic District boundary, facing northeast. It would be a contributing resource.

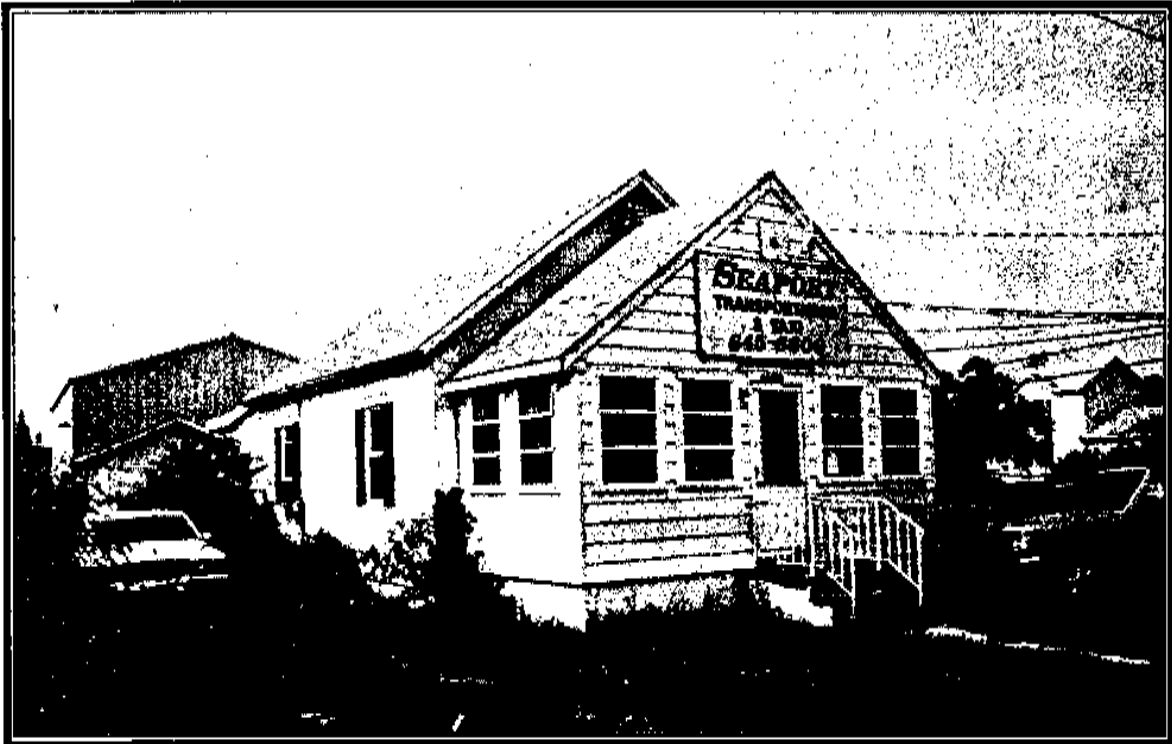
Photograph 17. S-8393, Belltown Historic District, building on lot 3-34-5-131, facing northeast. It is shown as Plate 10 in the Tidlow et al. 1990 report. Note the building's commercial use, and the large garage/industrial building that has been constructed to its rear.

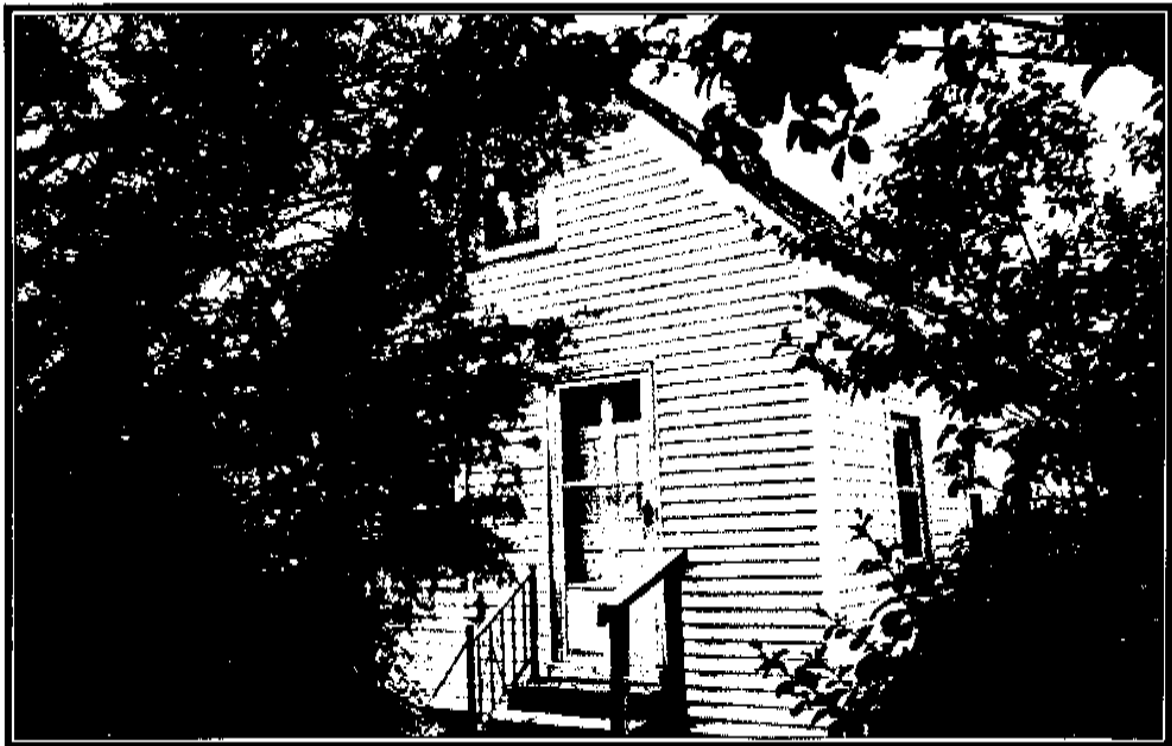
Photograph 18. S-8393, Belltown Historic District, house on lot 3-34-5-133, facing northwest. It is shown as Plate 14 in the Tidlow et al. 1990 report. Originally evaluated as a contributing resource, it has not changed.

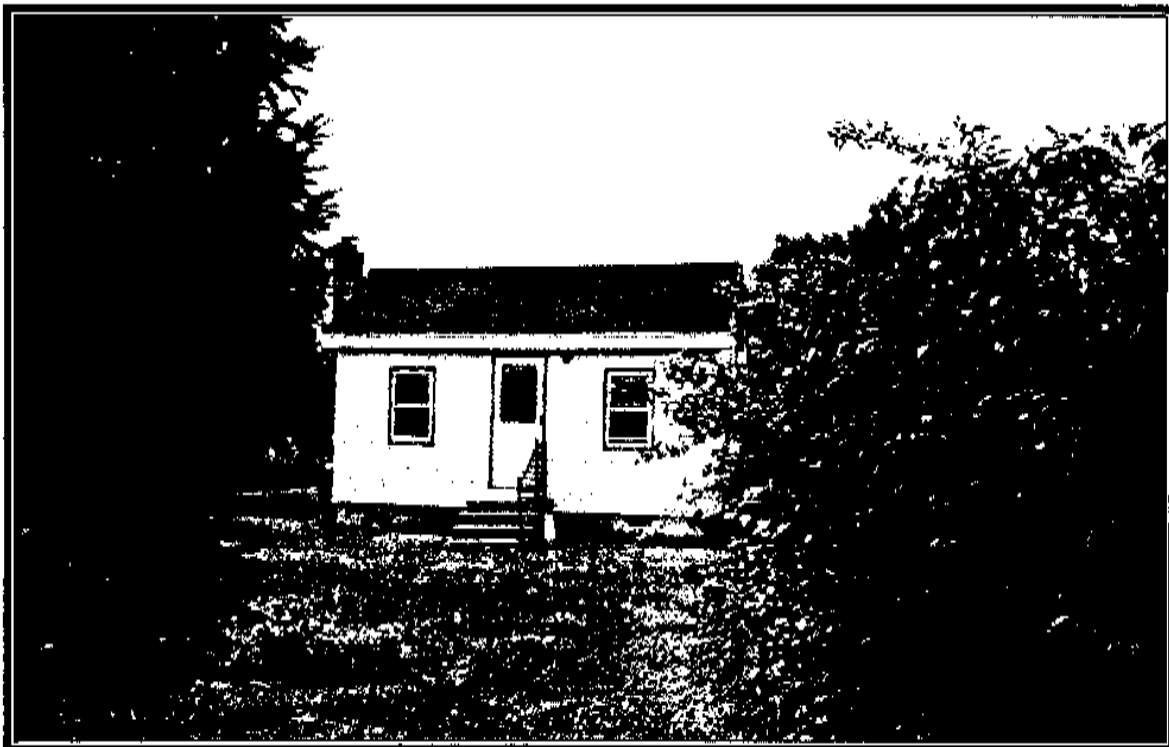
Photograph 19. S-8393, Belltown Historic District, house on lot 3-34-5-135.1, facing north. It is shown as Plate 11 in the Tidlow et al. 1990 report. Originally evaluated as a contributing resource, it has not changed.

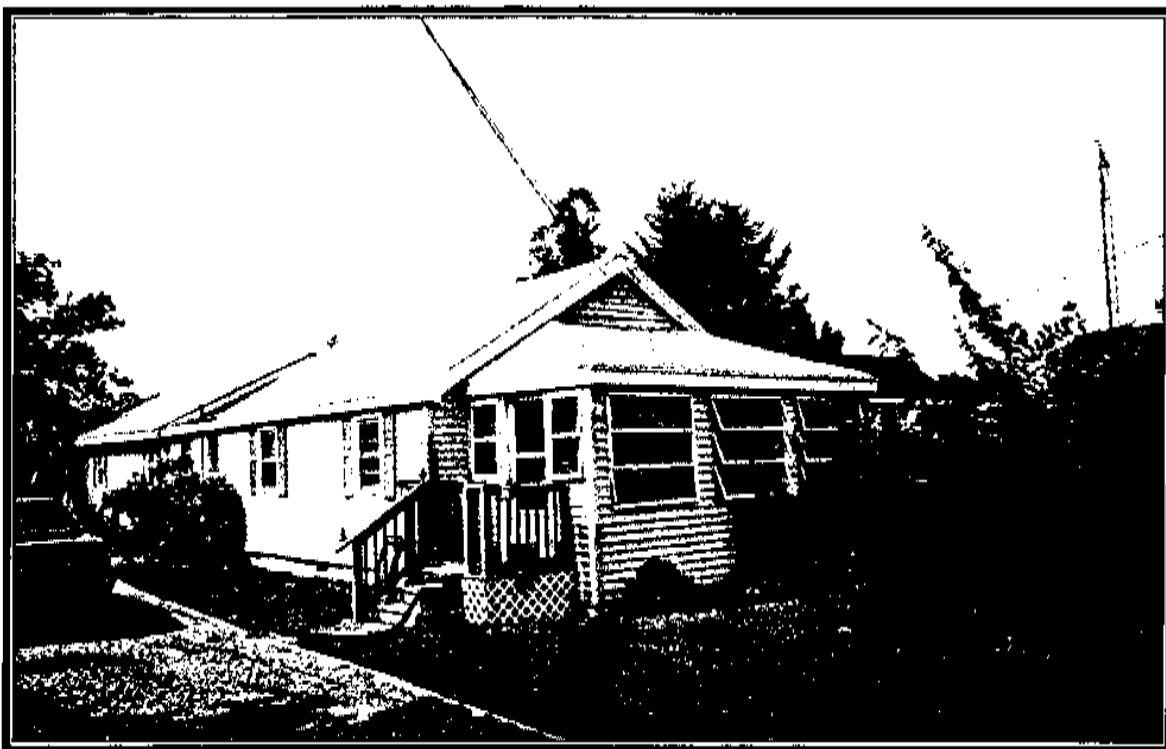
Photograph 20. S-8393, Belltown Historic District, house on lot 3-34-5-134, facing northeast. Originally evaluated as a contributing resource. It corresponds to Plate 15 in the Tidlow et al. 1990 report. Note the large addition at the rear.

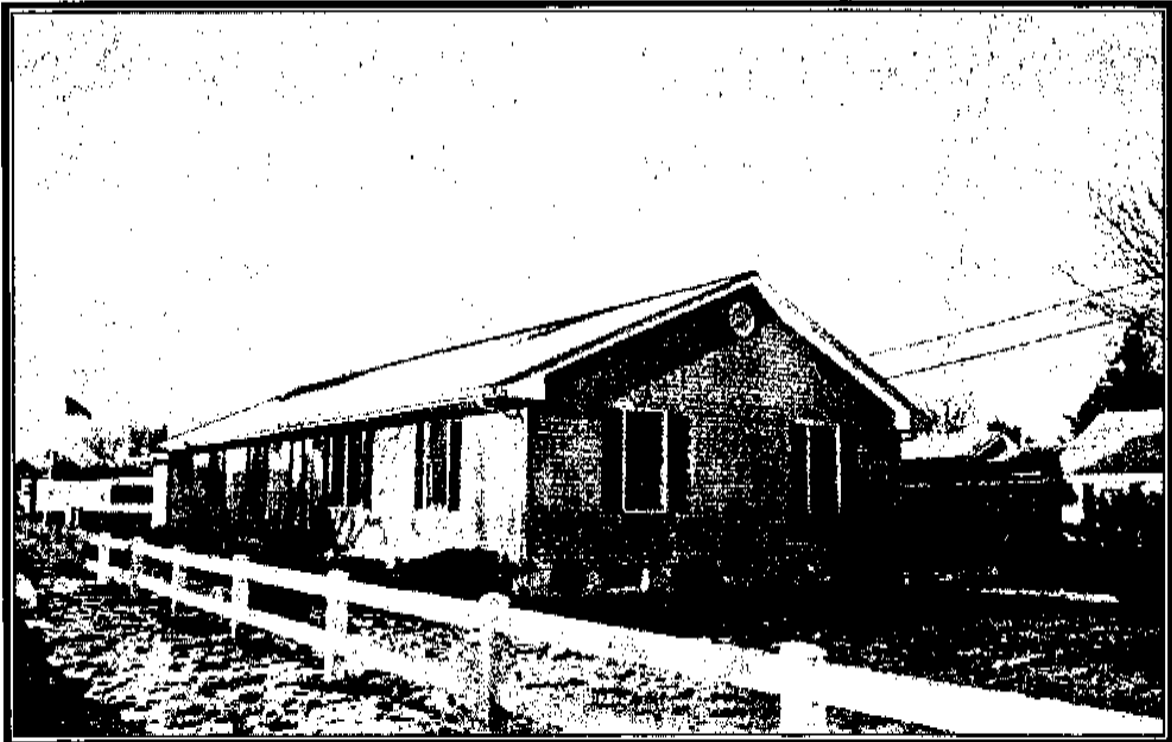
Photograph 21. S-8393, Belltown Historic District, house on lot 3-34-5-135, facing northeast. It replaced the contributing house shown as Plate 16 in the Tidlow et al. 1990 report.

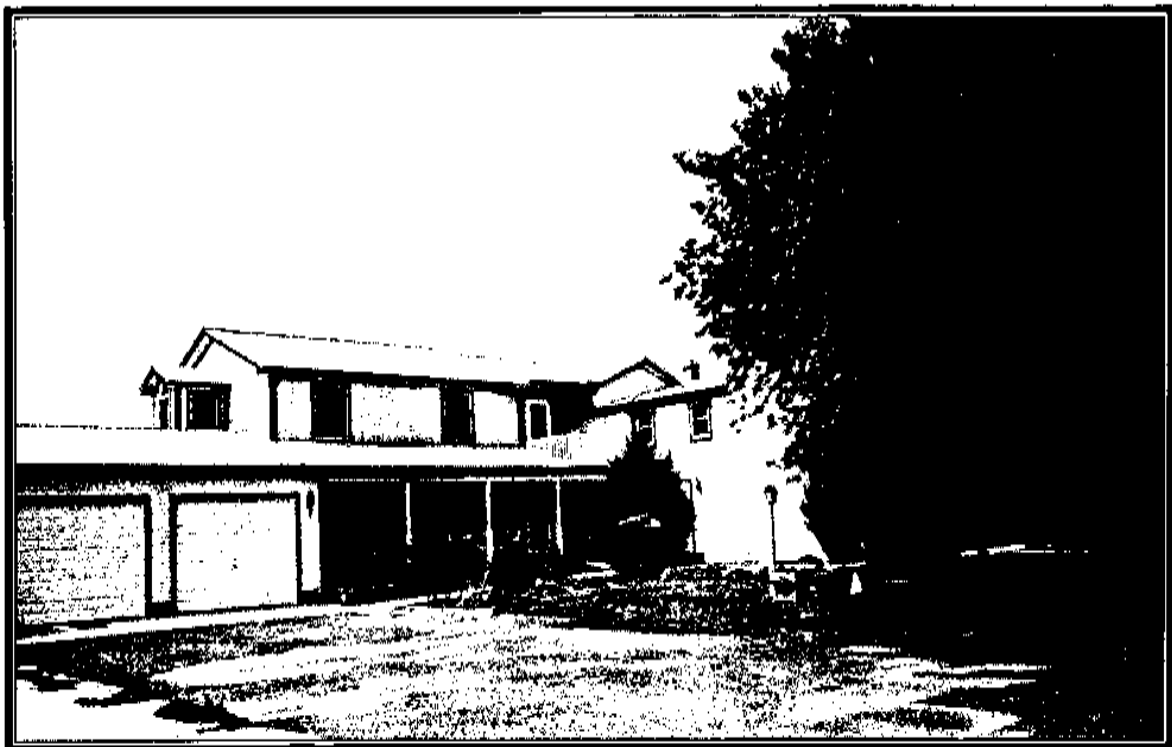
Photograph 22. S-8393, Belltown Historic District, house on lot 3-34-5-139, facing northeast. It corresponds to Plate 18 in the Tidlow et al. 1990 report. Now evaluated as noncontributing due to substantial alterations, including the two-story addition, porch, and garage.

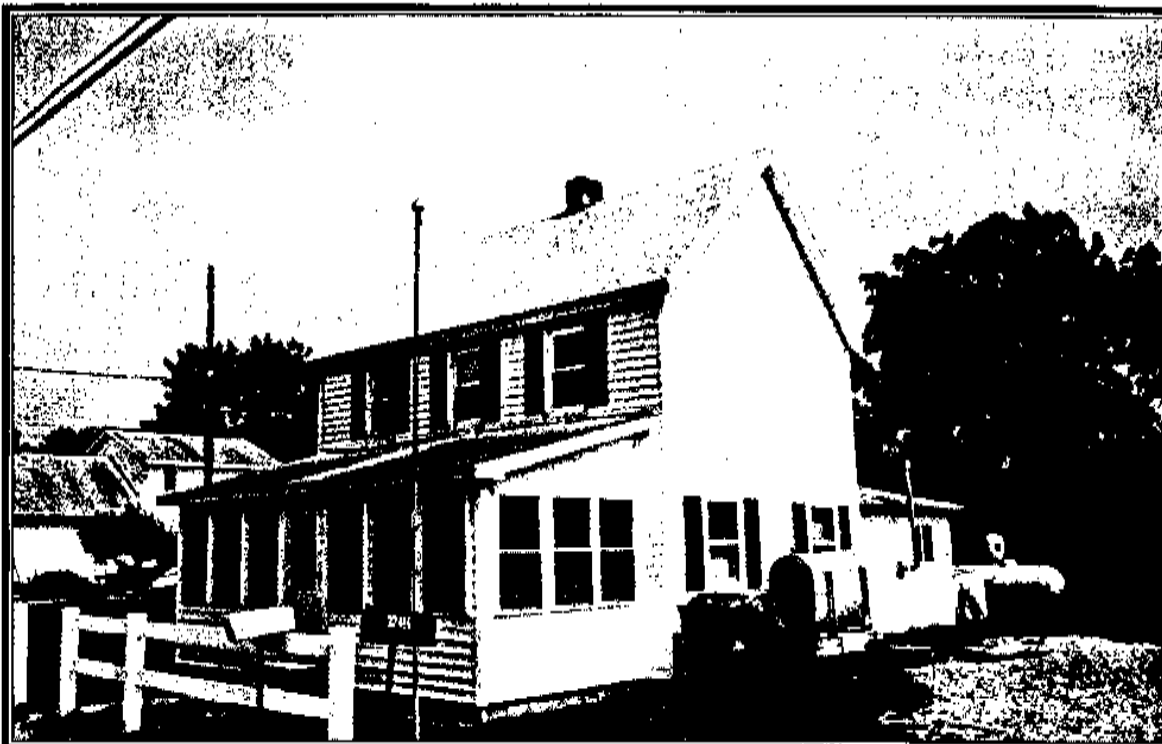
Photograph 23. S-8393, Belltown Historic District, house on lot 3-34-5-193, facing southeast. Evaluated as a contributing resource in 1989, it has not substantially changed. The house is shown as Plate 21 in the Tidlow et al. 1990 report.

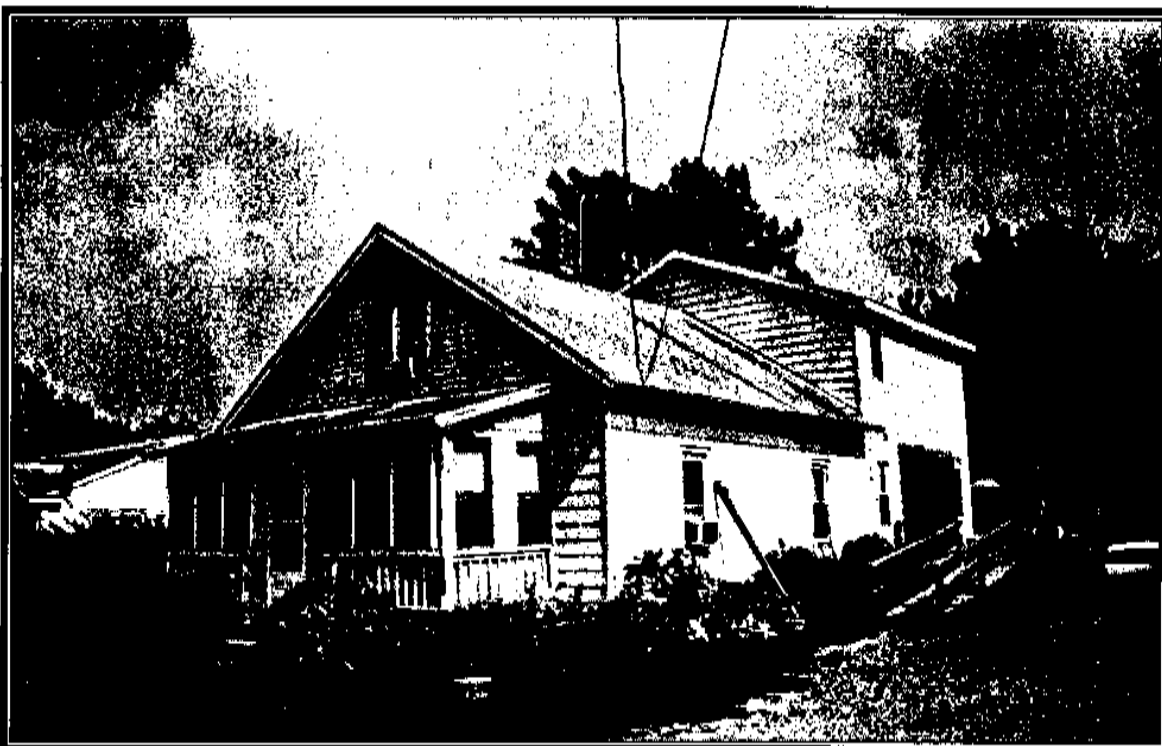
Photograph 24. S-8393, Belltown Historic District, house on lot 3-34-5-2-2, facing southeast. Evaluated as a contributing resource in 1989, the house is shown as Plate 26 in the Tidlow et al. 1990 report. Note the large addition appended to the rear.

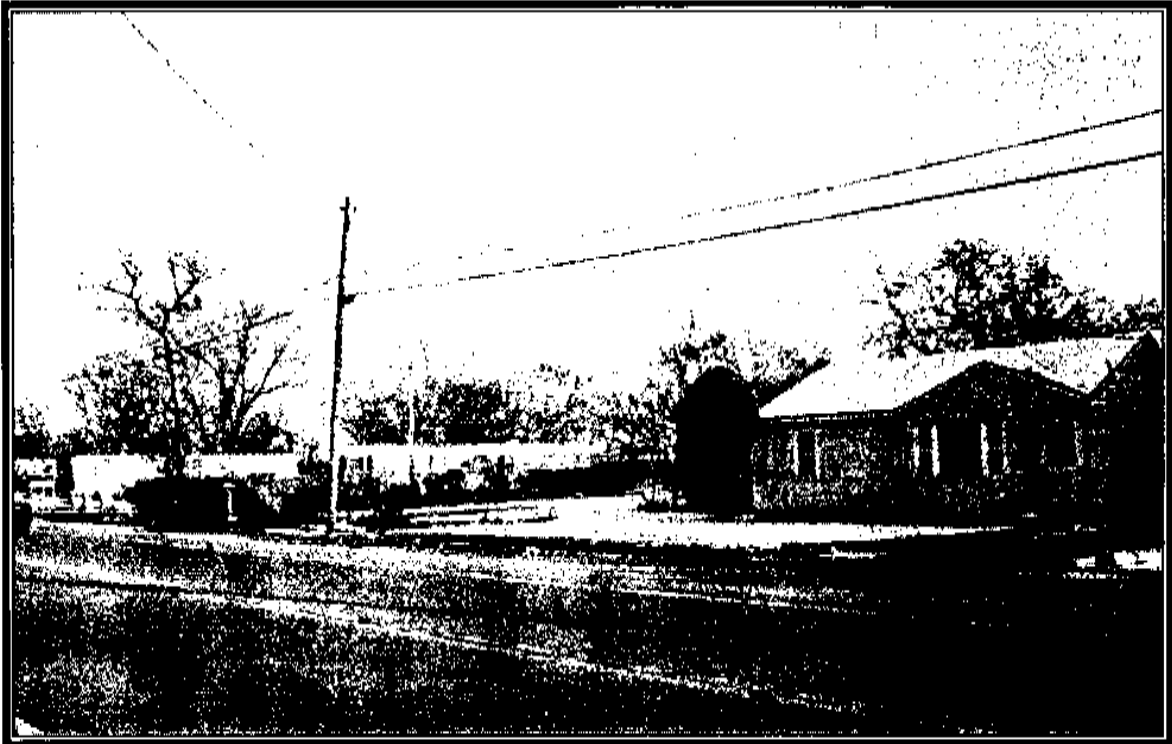
Photograph 25. S-8393, Belltown Historic District, noncontributing house and trailers that have replaced contributing resources on the south side of U.S. Route 9, facing southeast.
